**RESEARCH FROM THE UNIVERSITY OF ALABAMA AT
BIRMINGHAM**

Live/Real Time Three-Dimensional Transesophageal Echocardiographic Evaluation of Mitral and Aortic Valve Prosthetic Paravalvular Regurgitation

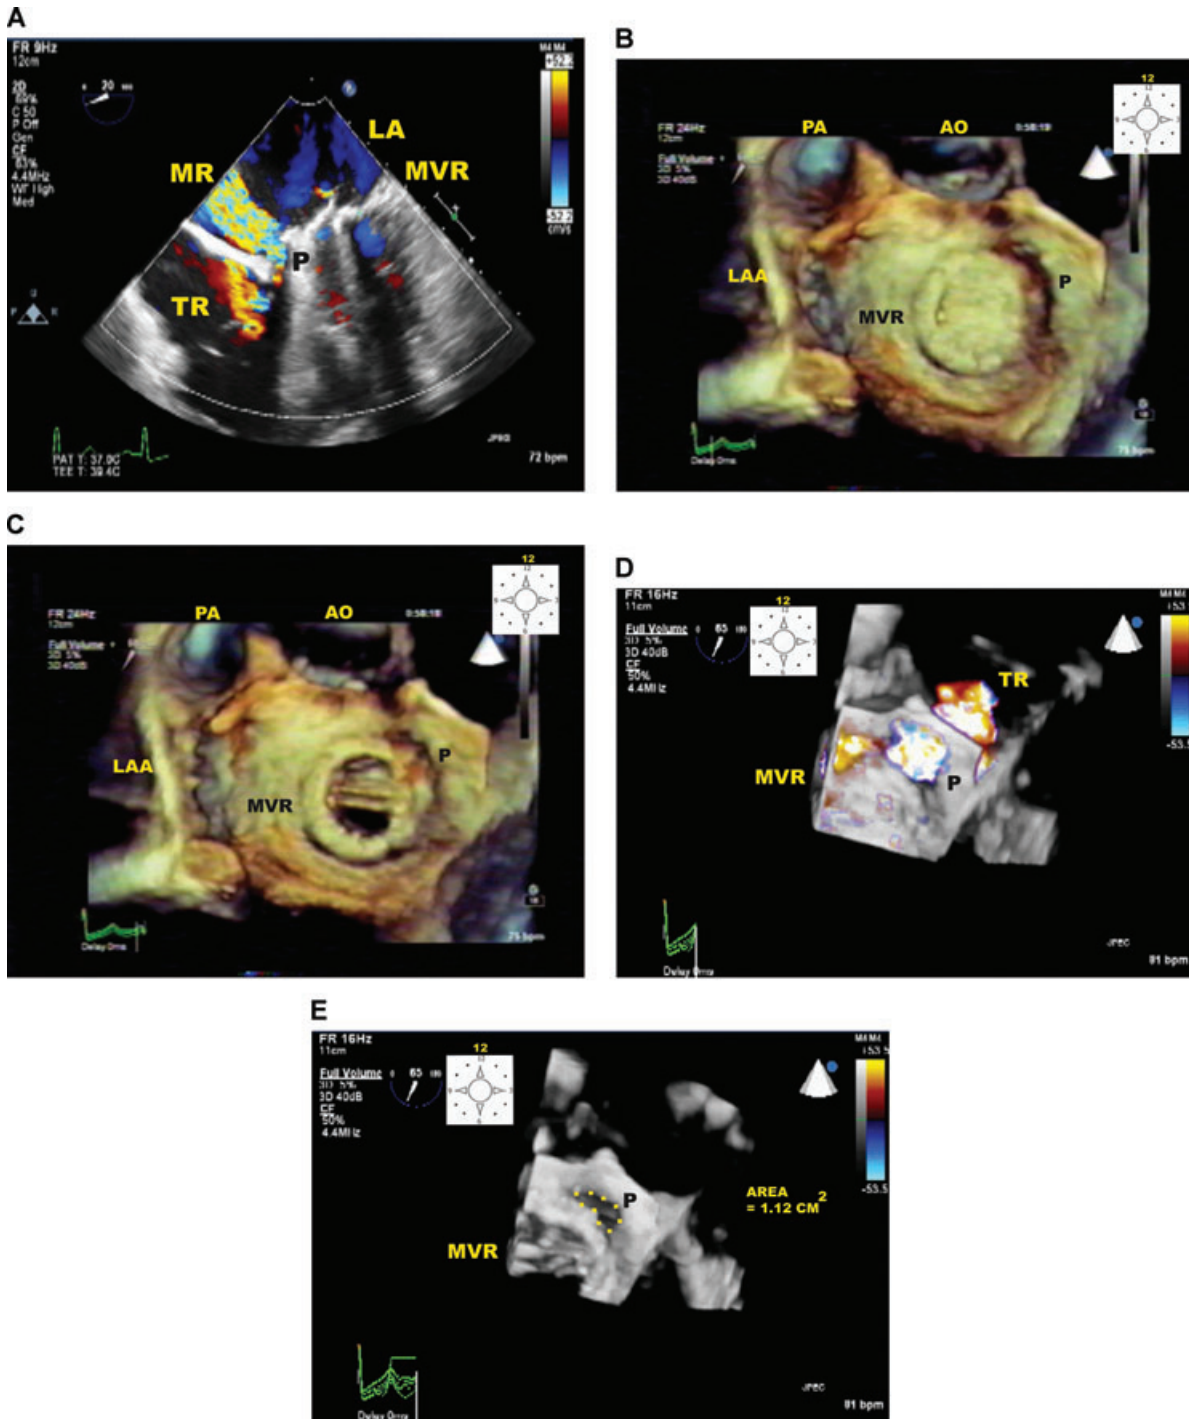
Figure 1. Paravalvular mitral prosthetic regurgitation (Case 1). **A.** Two-dimensional transesophageal echocardiogram shows medial paravalvular (P) mitral regurgitation (MR) in this patient with St Jude mitral valve replacement (MVR). **B–E.** Live/real time three-dimensional transesophageal echocardiogram. En face views. The paravalvular (P) defect is localized at the 1–3 o’clock position in both systole (**B**) and diastole (**C**). Color Doppler examination (**D**) confirms the site of the paravalvular (P) defect. The paravalvular (P) defect after color Doppler suppression is shown in **E**. The defect measured 1.12 cm². AO = aorta; LA = left atrium; LAA = left atrial appendage; PA = pulmonary artery; TR = tricuspid regurgitation.

In all of the patients, 3D TEE was able to provide more information regarding the location and size of the paravalvular defect as compared to 2D TEE (Table I, Figs. 1-6 with video clips). In the first patient, 3D TEE showed a defect at the 12-2 o'clock position, with dimensions of 1.3×1.2 cm which correlated well with the surgeon's finding of a 1.5×1.0 cm defect at the anterior annulus. In all of the other patients, 3D TEE again provided very good localization of the defect based on the surgeon's clock view or other landmarks. In addition to correlating well with the surgical findings, 3D TEE also provided an estimate of the size of the defect. In one patient with a mitral prosthetic leak, fewer sutures were visualized in the region of

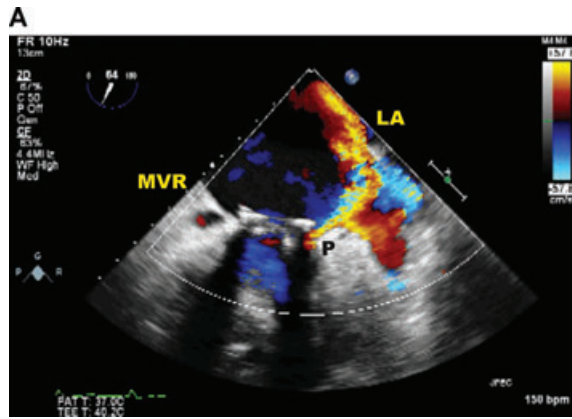
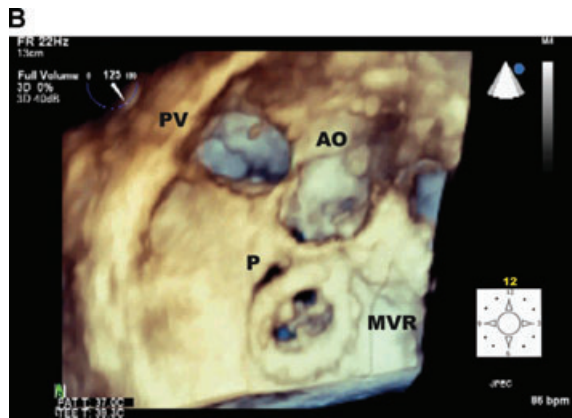
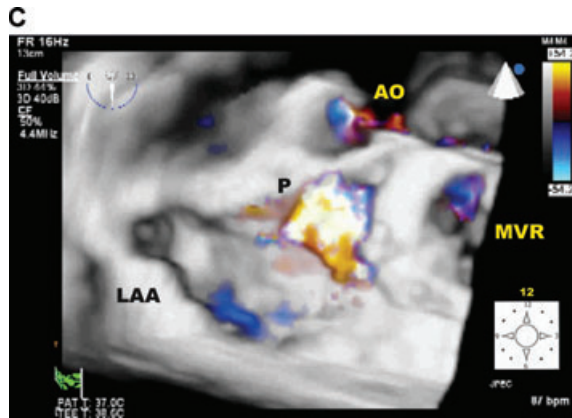
Figure 2. Paravalvular mitral prosthetic regurgitation (Case 9). **A.** Two-dimensional transesophageal echocardiogram shows lateral paravalvular (P) MR in this patient with porcine MVR. **B, C.** Live/real time three-dimensional transesophageal echocardiogram. En face views. The paravalvular (P) defect is localized at the 10–11 o'clock position (**B**). Color Doppler examination (**C**) confirms the site of the defect. PV = pulmonary valve. Other abbreviations as in the previous figure.

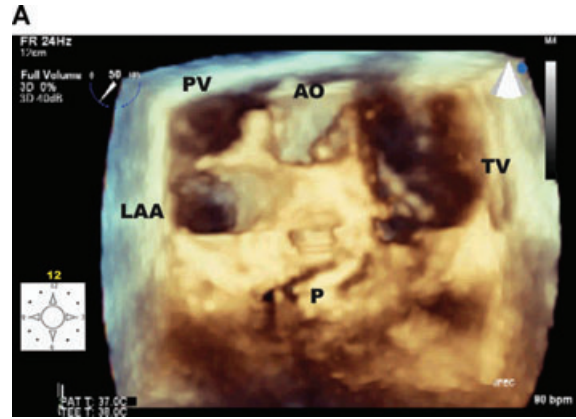
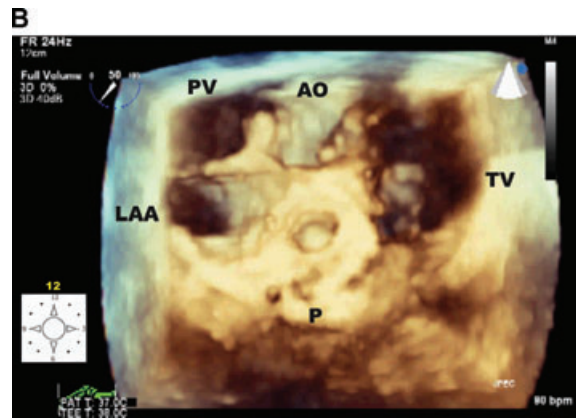
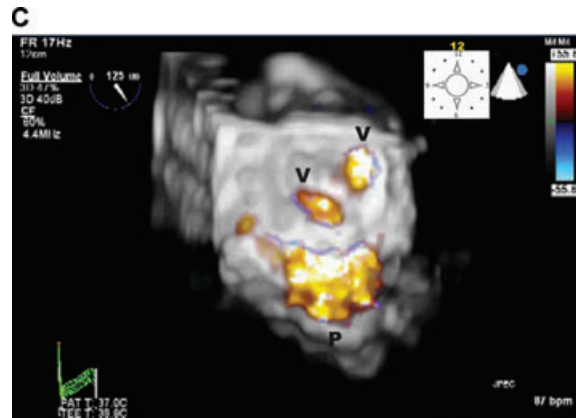
Figure 3. Paravalvular mitral prosthetic regurgitation (Case 8). **A–C.** Live/real time three-dimensional transesophageal echocardiogram. En face views. The paravalvular (P) defect is localized at the 5–8 o'clock position in both systole (**A**) and diastole (**B**) in this patient with Starr Edwards MVR. Color Doppler examination (**C**) confirms the site of paravalvular (P) defect. TV = tricuspid valve; V = valvular regurgitation. Other abbreviations as in previous figures.

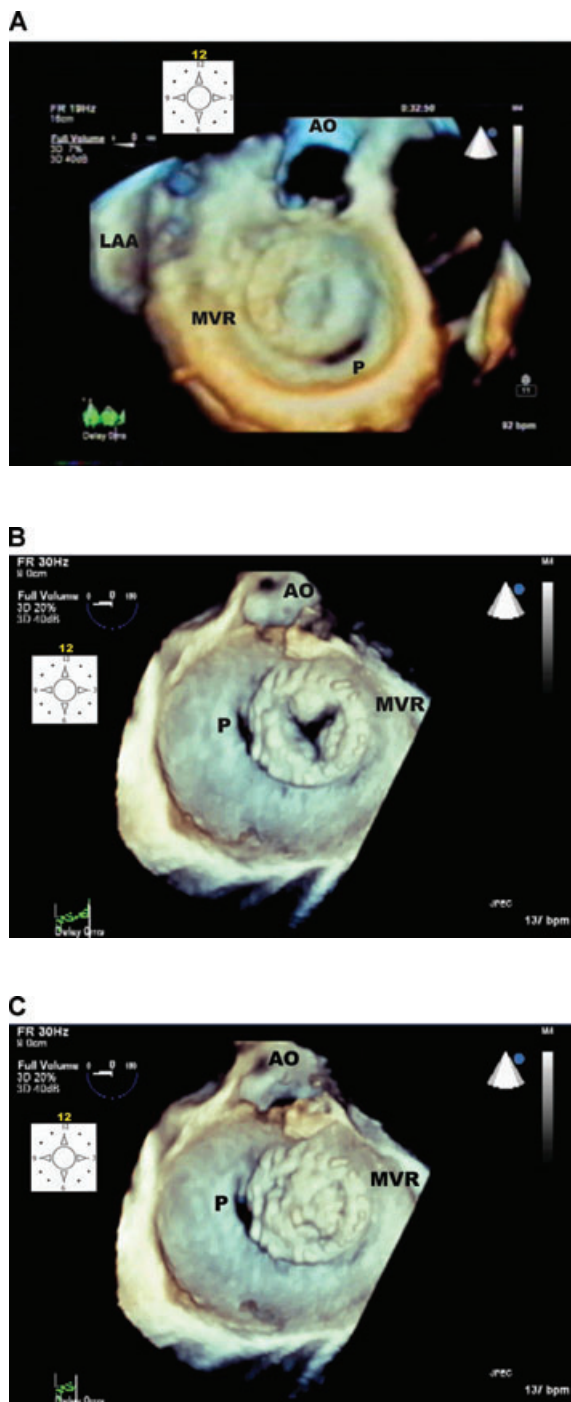
Figure 4. Paravalvular mitral prosthetic regurgitation. Live/real time three-dimensional transesophageal echocardiogram. En face views. **A** (Case 2). The paravalvular (P) defect is localized at the 5 o'clock position in this patient with a metallic prosthesis. **B, C** (Case 10). Another patient with a tissue prosthesis shows paravalvular (P) defect at the 8–9 o'clock position in both systole and diastole. Abbreviations as in previous figures.

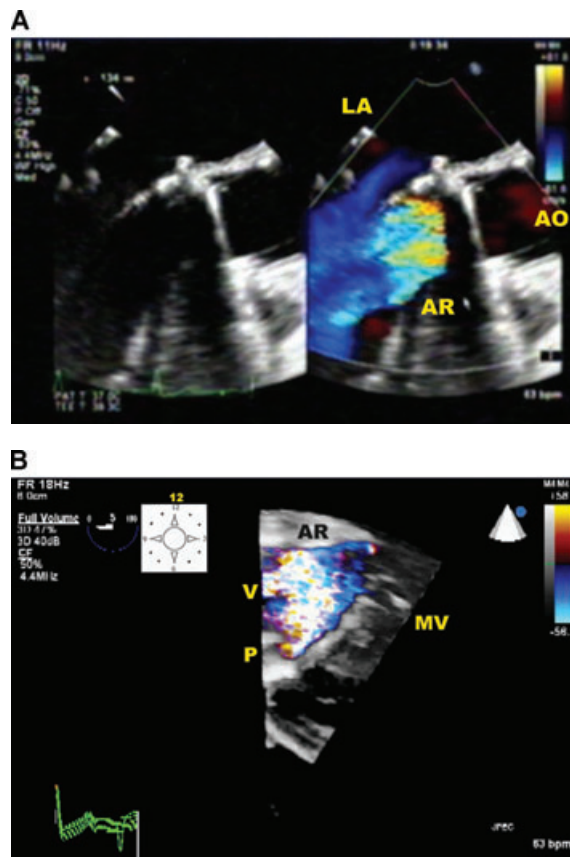
Figure 5. Paravalvular aortic prosthetic regurgitation (Case 12). **A.** Two-dimensional transesophageal echocardiogram. In this patient with a metallic prosthesis, color Doppler signals fill the whole extent of proximal left ventricular outflow tract in diastole consistent with severe aortic regurgitation (AR). It is difficult to assess the site of AR but it appears primarily valvular, not paravalvular. **B.** Live/real time three-dimensional transesophageal echocardiogram. Paravalvular (P) regurgitation is located at the 7 o'clock position. Two jets of valvular (V) regurgitation are also visualized within the confines of the prosthesis. MV = mitral valve. Other abbreviations as in previous figures.

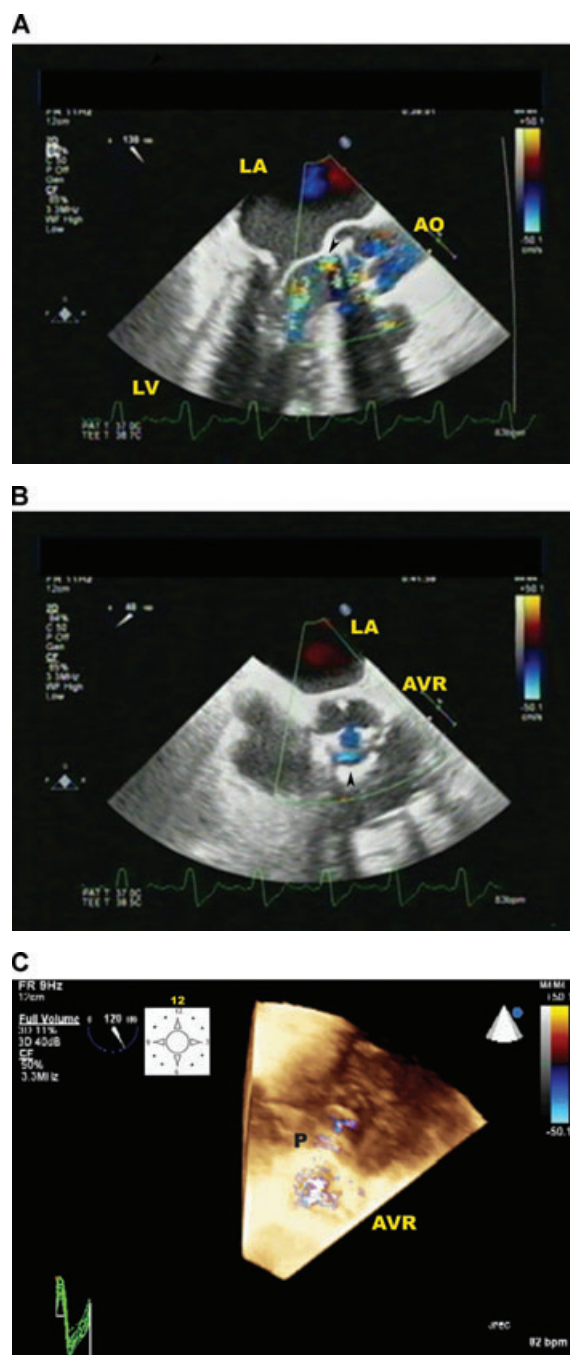
Figure 6. Paravalvular aortic prosthetic regurgitation (Case 13). **A, B.** Two-dimensional transesophageal echocardiogram. Both posterior (A) and anterior (B) paravalvular (P) regurgitation jets (arrow head) are seen in five-chamber and short-axis views, respectively, in this patient with a tissue aortic valve replacement (AVR). **C.** Live/real time three-dimensional transesophageal echocardiogram. A large paravalvular (P) defect is seen anteriorly at the 1 o'clock position. LV = left ventricle. Other abbreviations as in previous figures.
